**WATER CIVIL
ENGINEERING
STRUCTURES**

**REPAIR, PROTECTION
AND STRENGTHENING**

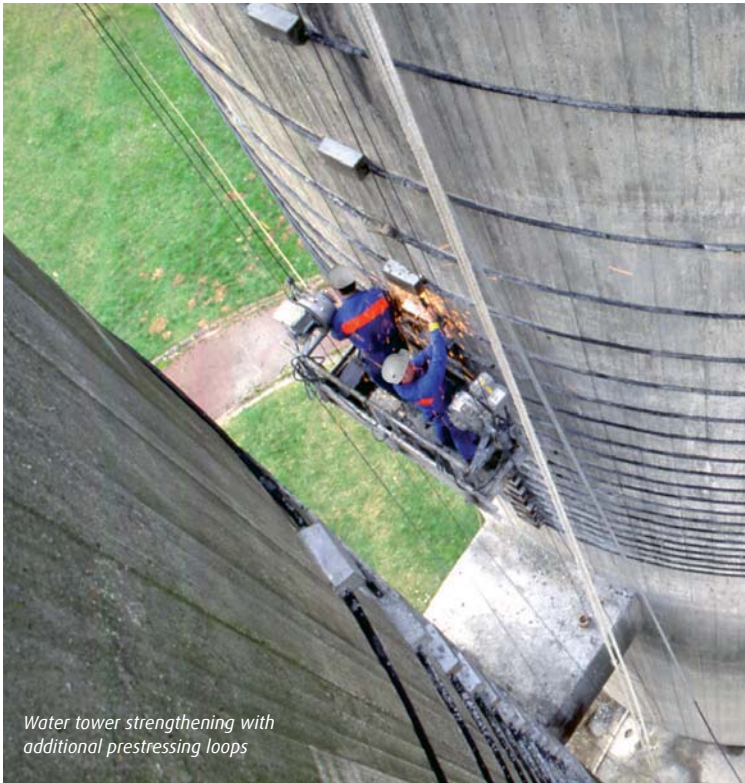
Water tower strengthening with additional prestressing loops

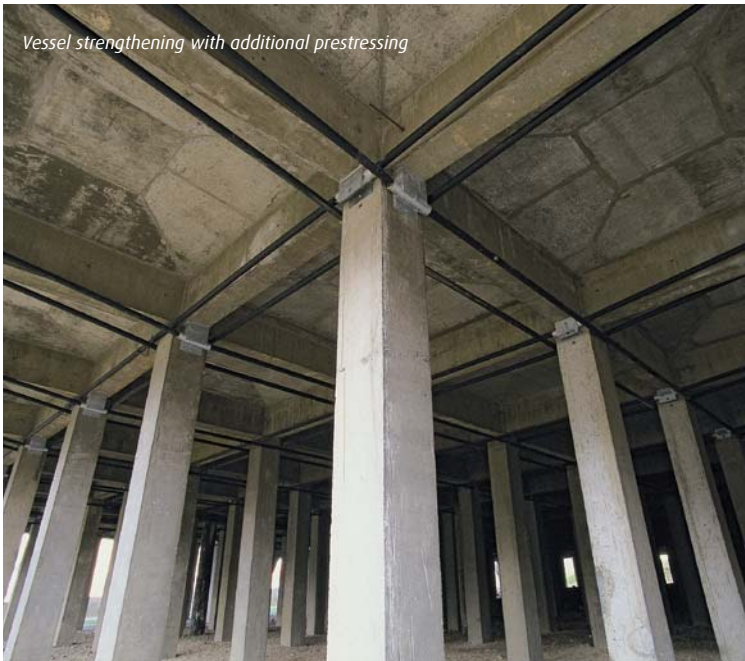
Vessel strengthening with additional prestressing

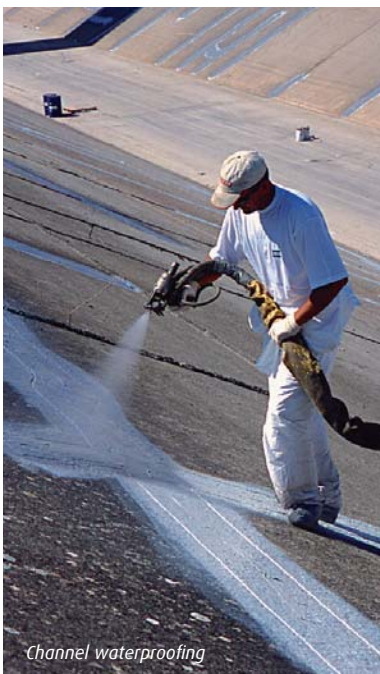
Channel waterproofing

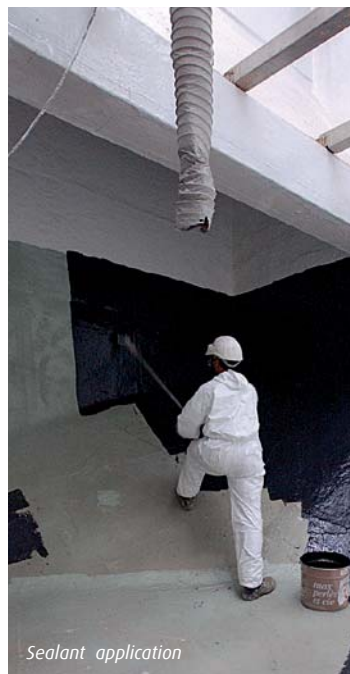
Sealant application

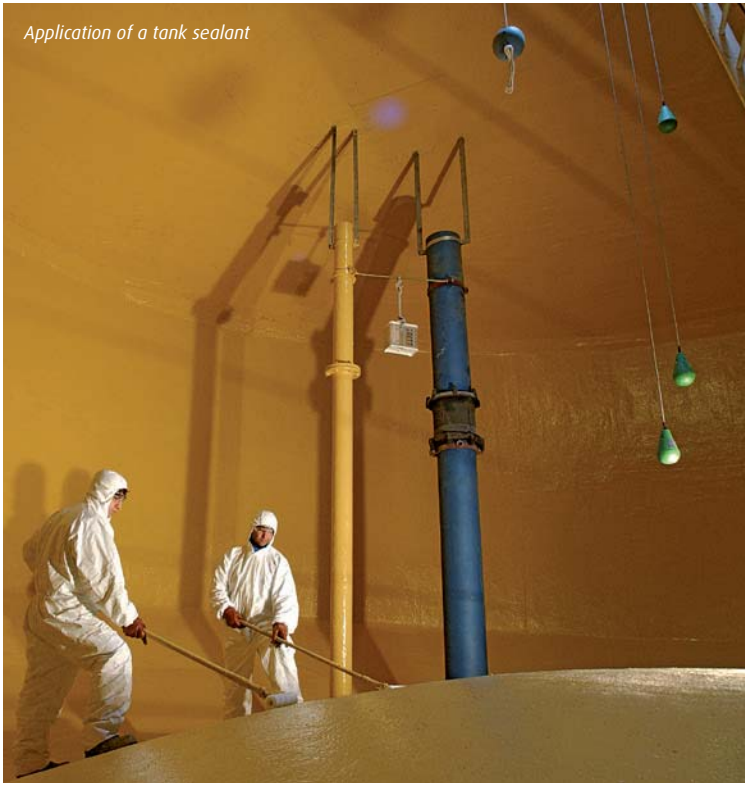
Application of a tank sealant

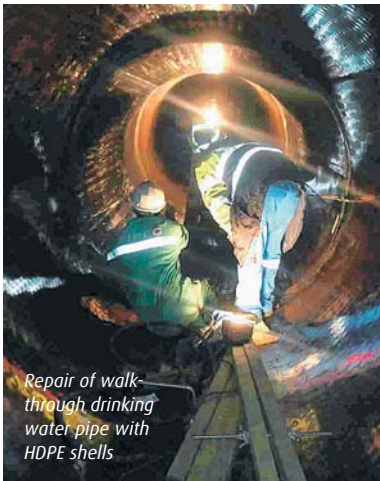
Repair of walk-through drinking water pipe with HDPE shells

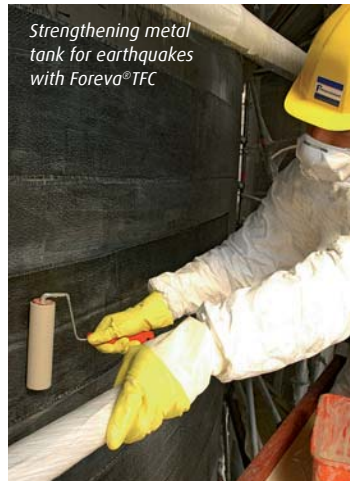
Strengthening metal tank for earthquakes with Foreva® TFC

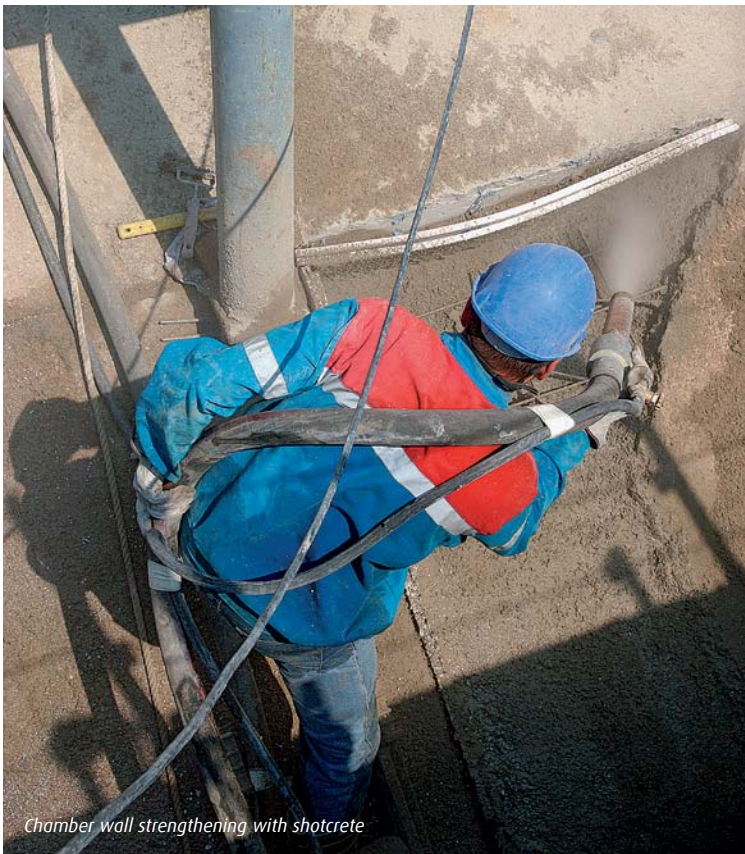
Chamber wall strengthening with shotcrete
